**Flood Control Project Maintenance
Levee Inspections**

2013 Channel Summary Report

Fairfield Suisun Sewer District

Flood Control Project Maintenance**Unit Cover Sheet****2013 Channel Inspection Results****Fairfield Suisun Sewer District**

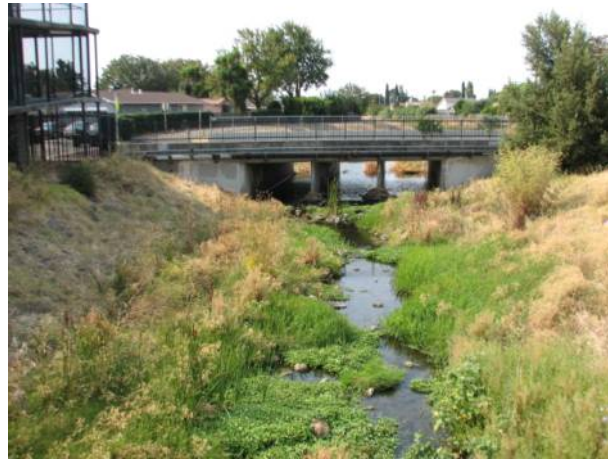
johngw_c_20130822_094.JPG

Looking downstream towards Nightingale at Air Base Parkway (Summer 2013)

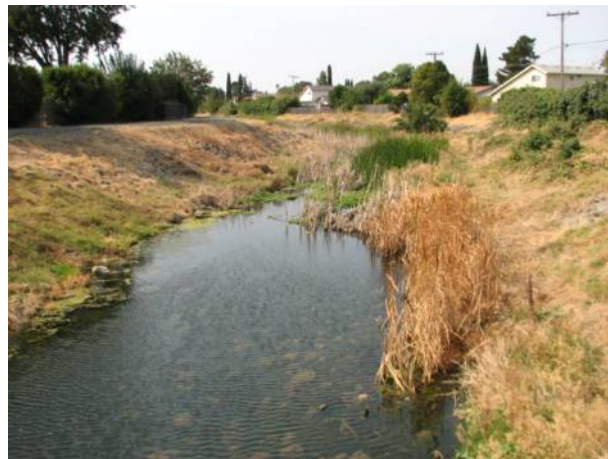
johngw_c_20130822_095.JPG

Looking downstream at Nightingale (Summer 2013)

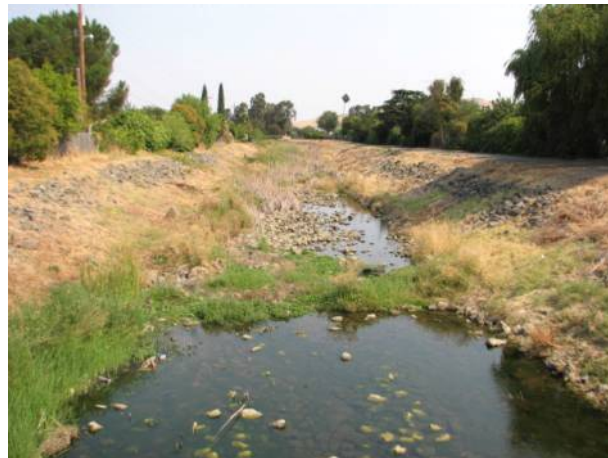
johngw_c_20130822_096.JPG

Looking upstream at Meadowlark Drive (Summer 2013)

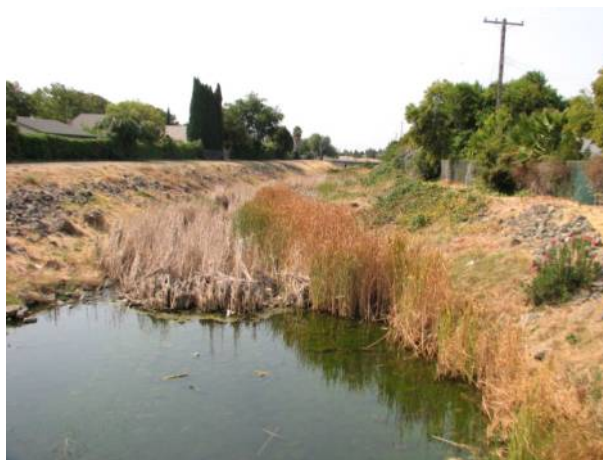
johngw_c_20130822_097.JPG

Looking downstream at Meadowlark Drive
(Summer 2013)

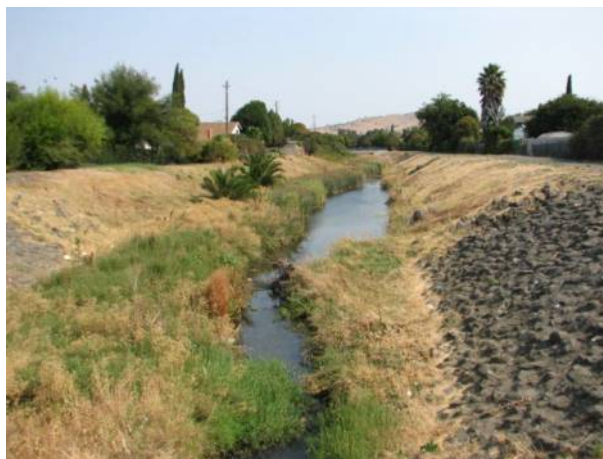
johngw_c_20130822_098.JPG

Looking upstream at E. Tabor Avenue (Summer 2013)

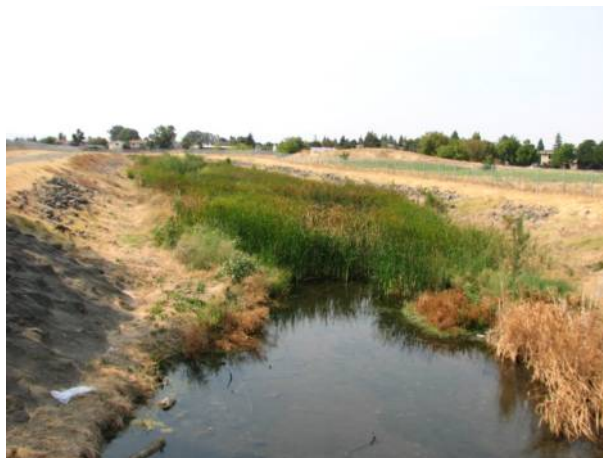
johngw_c_20130822_099.JPG

Looking downstream at E. Tabor Avenue
(Summer 2013)

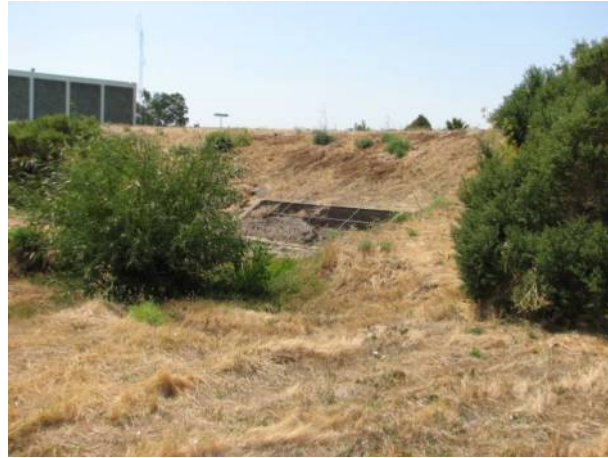
johngw_c_20130822_127.JPG

Looking at the Inlet in the retention basin.
Suggest removal of Willow in front of grate.
(Summer 2013)

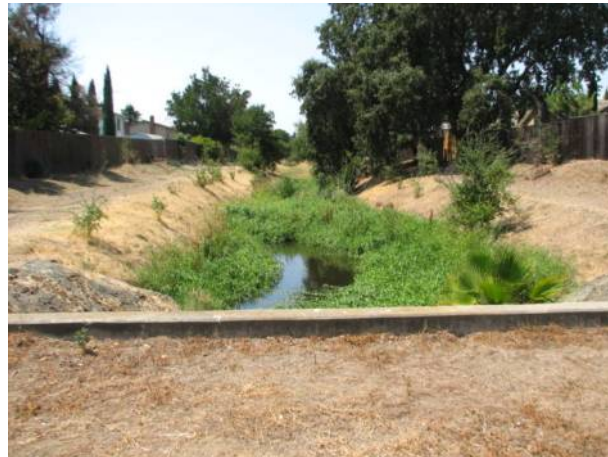
johngw_c_20130822_128.JPG

Outlet side of the pipe into Ledgewood Creek
towards Astoria Drive (Summer 2013)

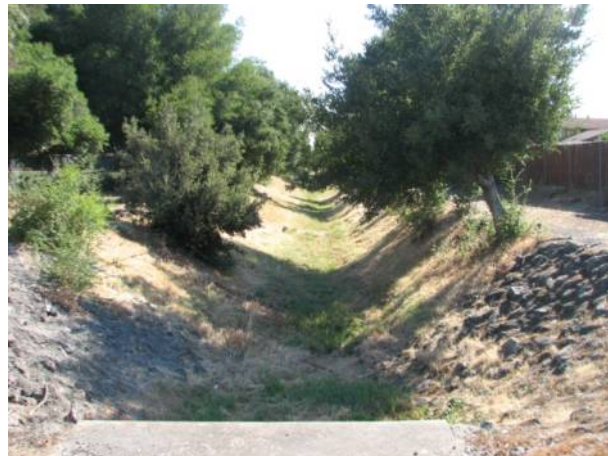
johngw_c_20130822_129.JPG

Looking upstream at Astoria Drive. (Summer 2013)

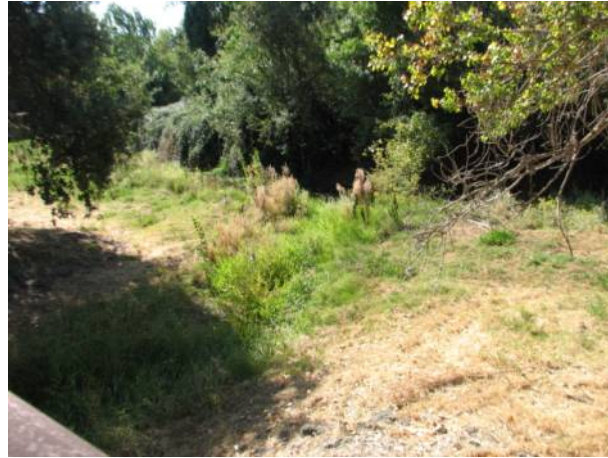
johngw_c_20130822_133.JPG

Looking at junction of Ledgewood Creek at Springfield Drive (Summer 2013)

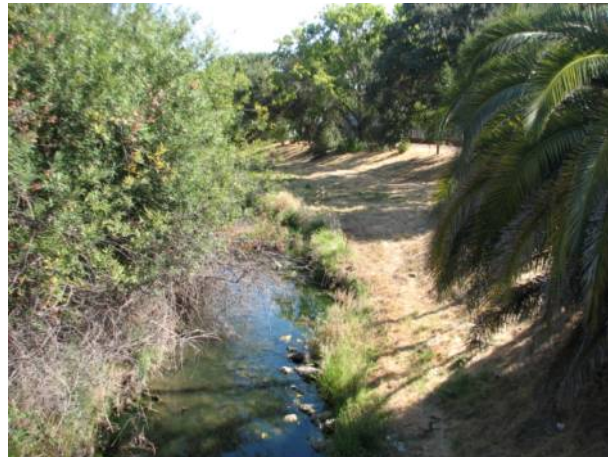
johngw_c_20130822_135.JPG

Looking upstream at Rockville Road (Summer 2013)

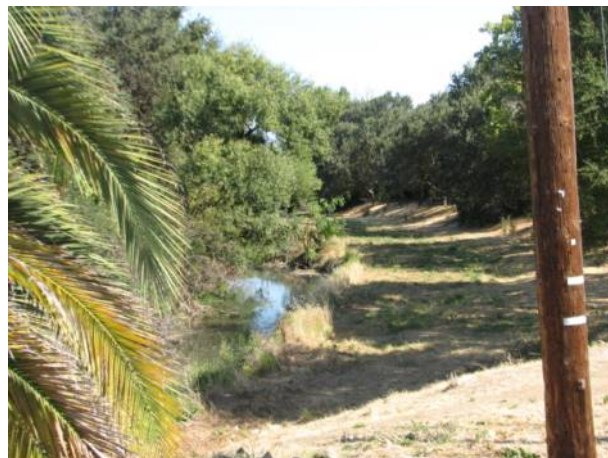
johngw_c_20130822_136.JPG

Another view looking up stream at Rockville Road (Summer 2013)

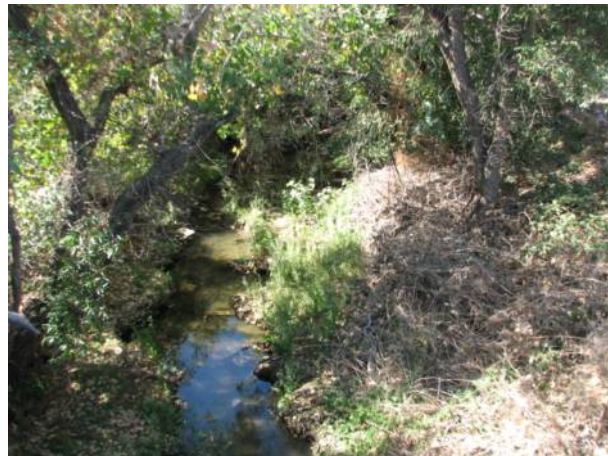
johngw_c_20130822_137.JPG

Looking downstream at Rockville Road (Summer 2013)

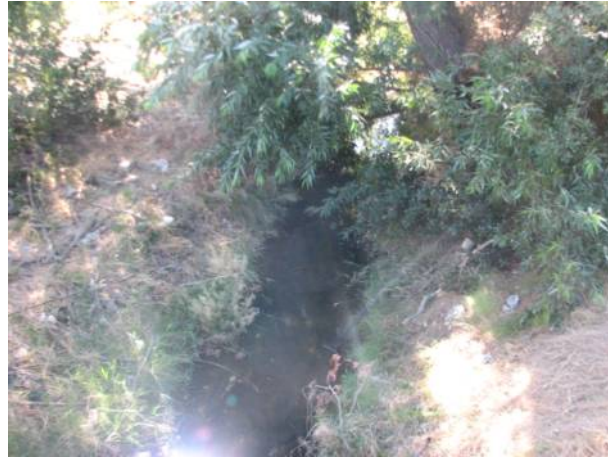
johngw_c_20130822_144.JPG

Looking downstream At the historical channel at Woolner Avenue (Summer 2013)

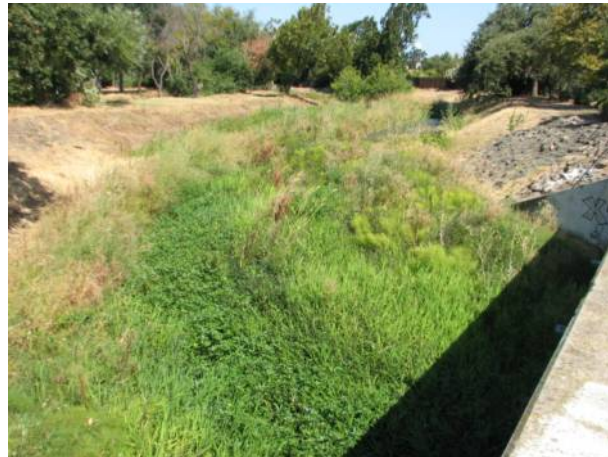
johngw_c_20130822_145.JPG

Looking upstream at Beck Avenue (Summer 2013)

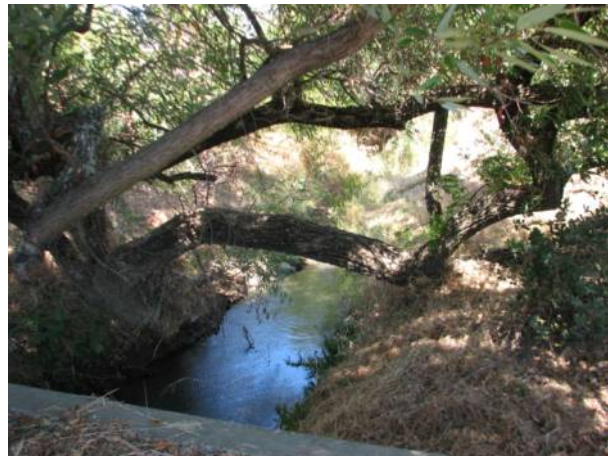
johngw_c_20130822_146.JPG

Upstream view of the historical channel at Beck Avenue (Summer 2013)

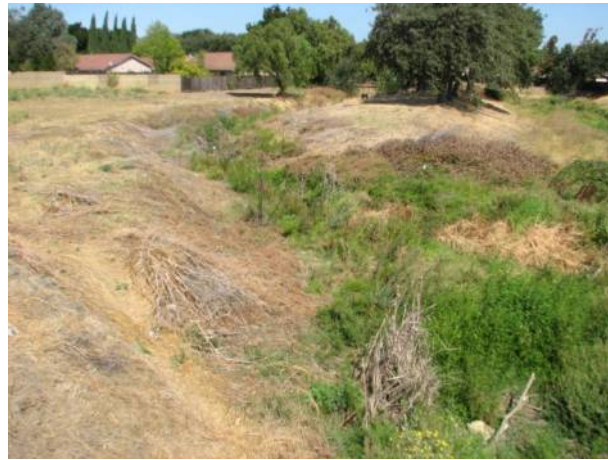
johngw_c_20130822_150.JPG

A view looking upstream of the historical channel at Highway 12 (Summer 2013)

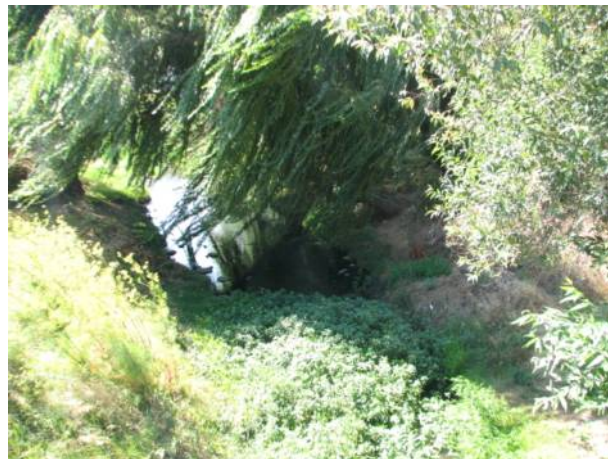
johngw_c_20130822_151.JPG

Looking downstream at Highway 12 (Summer 2013)

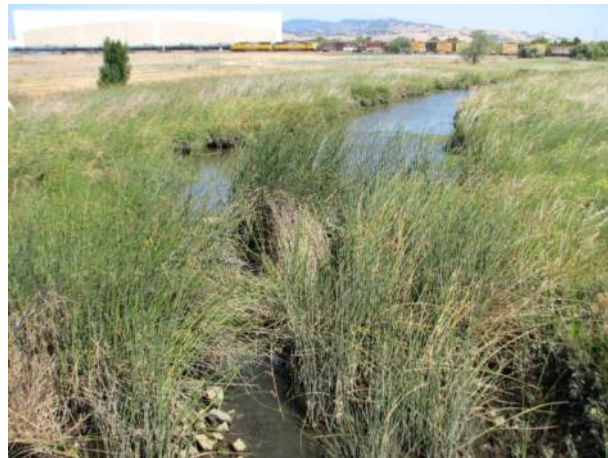
johngw_c_20130822_152.JPG

Looking upstream at Cordelia Road (Summer 2013)

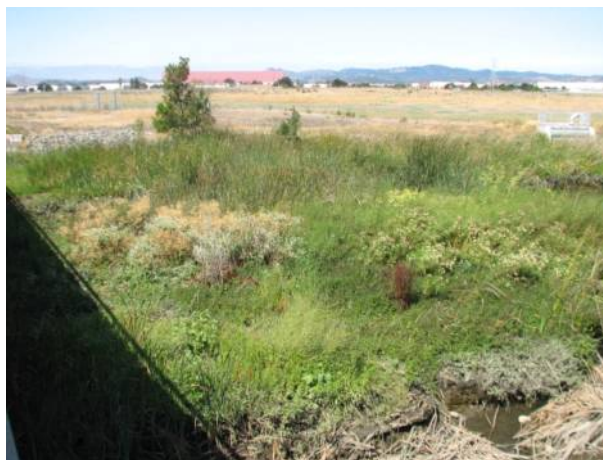
johngw_c_20130822_153.JPG

Sedimentation upstream at Cordelia Road
(Summer 2013)

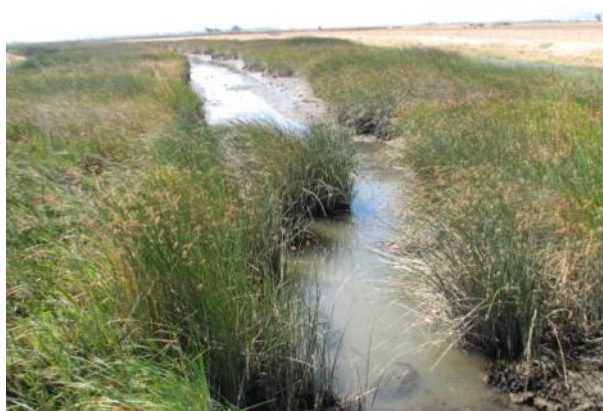
johngw_c_20130822_154.JPG

Looking downstream towards Suisun Bay at
Cordelia Road (Summer 2013)

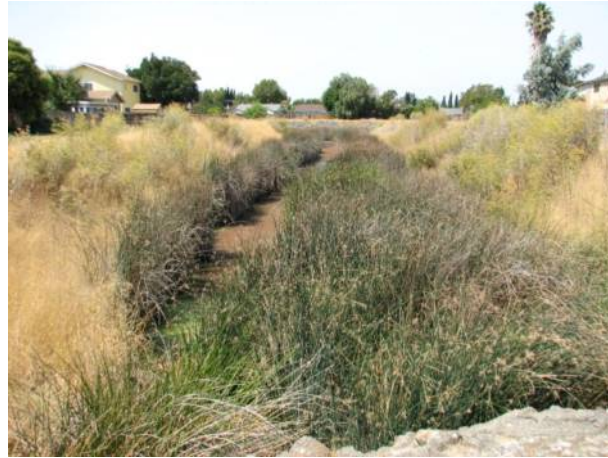
Levee Mile Report Line	16
Start Levee Mile	0.00
End Levee Mile	0.00
Location	
Category	Channels
Item	Vegetation & Obstructions
Looking downstream towards the junction of Laurel Creek (Summer 2013)	
johngw_c_20130822_120.JPG

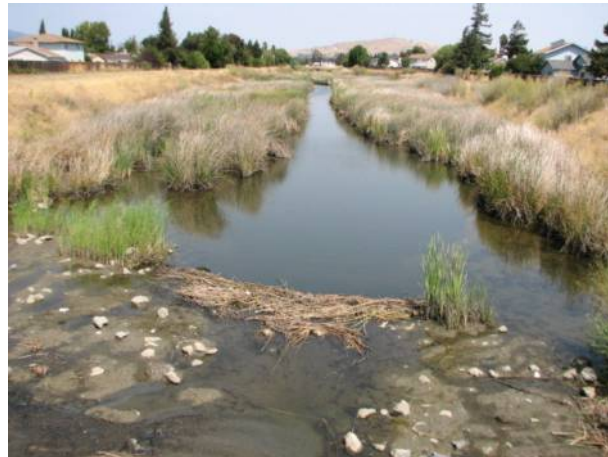
Levee Mile Report Line	21
Start Levee Mile	0.00
End Levee Mile	0.00
Location	
Category	Channels
Item	Vegetation & Obstructions
Looking upstream at Pintail Drive (Summer 2013)	
johngw_c_20130822_121.JPG

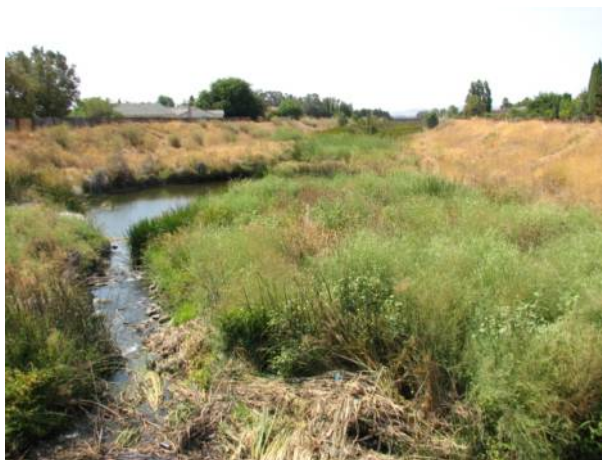
Levee Mile Report Line	26
Start Levee Mile	0.00
End Levee Mile	0.00
Location	
Category	Channels
Item	Vegetation & Obstructions

Looking downstream at Pintail Drive (Summer 2013)

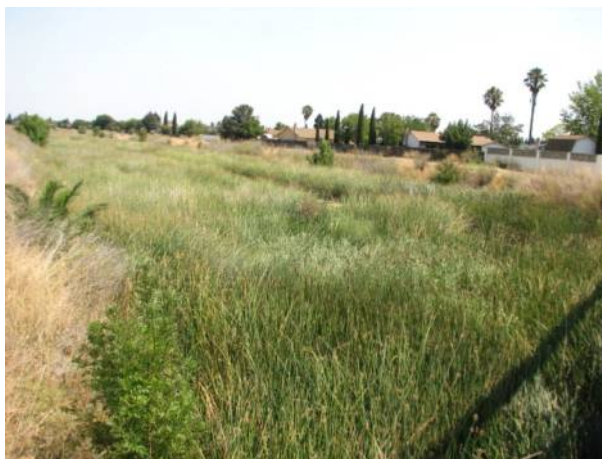
Levee Mile Report Line	31
Start Levee Mile	0.00
End Levee Mile	0.00
Location	
Category	Channels
Item	Vegetation & Obstructions

Looking up stream at Highway 12 (Summer 2013)

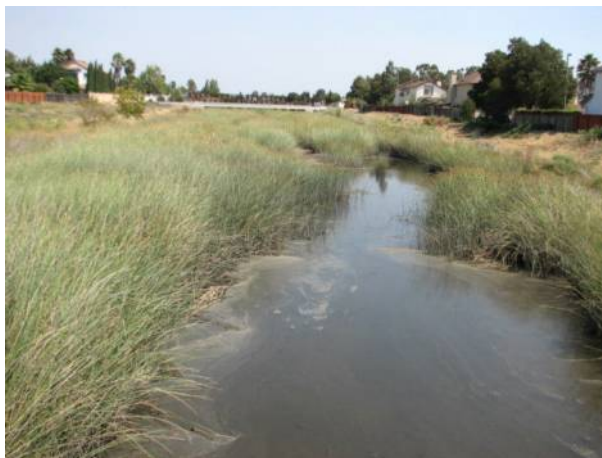
Levee Mile Report Line	31
Start Levee Mile	0.00
End Levee Mile	0.00
Location	
Category	Channels
Item	Vegetation & Obstructions

Looking up stream towards Highway 12 from Anderson Drive (Summer 2013)

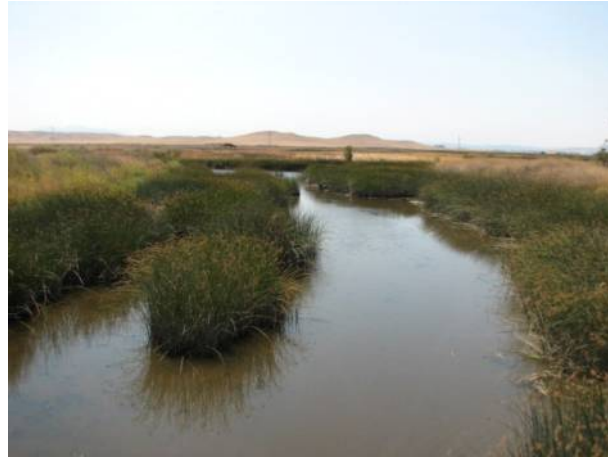
Levee Mile Report Line	36
Start Levee Mile	0.00
End Levee Mile	0.00
Location	
Category	Channels
Item	Vegetation & Obstructions
Looking downstream towards Suisun Bay at Anderson Drive (Summer 2013)	
johngw_c_20130822_126.JPG

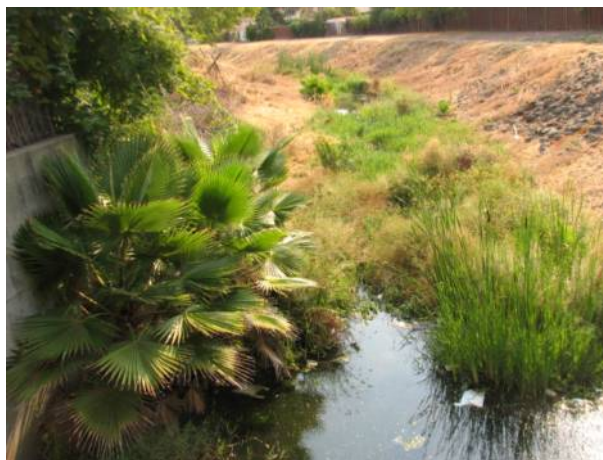
Looking downstream at N. Texas Street. Suggest removal of the Palms. (Summer 2013)

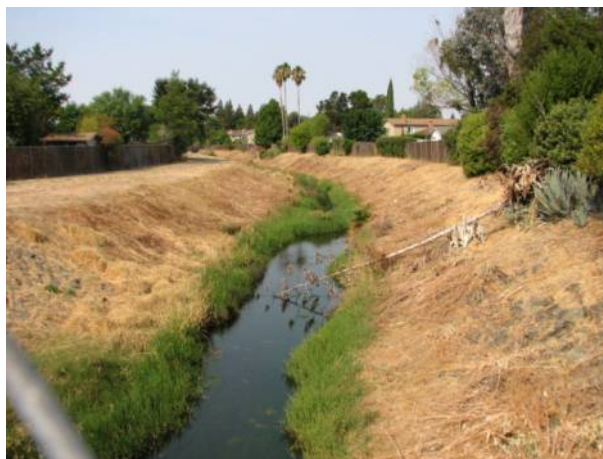
Levee Mile Report Line	6
Start Levee Mile	0.00
End Levee Mile	0.00
Location	
Category	Channels
Item	Vegetation & Obstructions

Looking upstream at Camrose Avenue (Summer 2013)

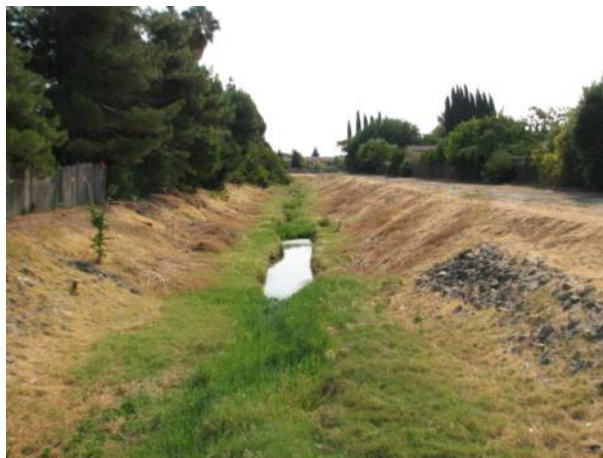
Levee Mile Report Line	11
Start Levee Mile	0.00
End Levee Mile	0.00
Location	
Category	Channels
Item	Vegetation & Obstructions

Looking downstream at Camrose Avenue (Summer 2013)

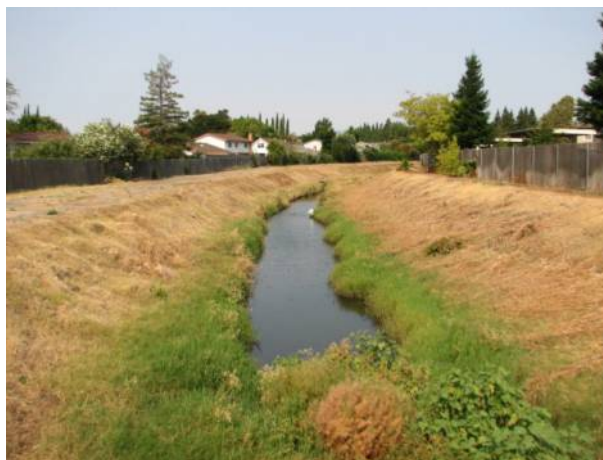
Looking upstream at Dover Avenue (Summer 2013)

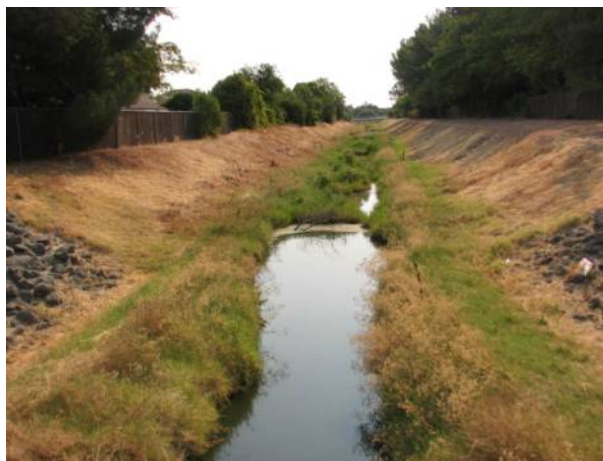
Levee Mile Report Line	21
Start Levee Mile	0.00
End Levee Mile	0.00
Location	
Category	Channels
Item	Vegetation & Obstructions

Looking downstream at Dover Avenue (Summer 2013)

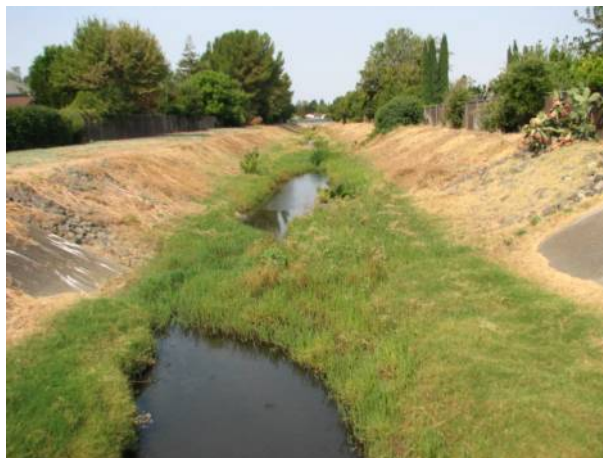
Levee Mile Report Line	26
Start Levee Mile	0.00
End Levee Mile	0.00
Location	
Category	Channels
Item	Vegetation & Obstructions

Looking upstream at Gulf Drive. Sedimentation starting to obstruct low flow channel. (Summer 2013)

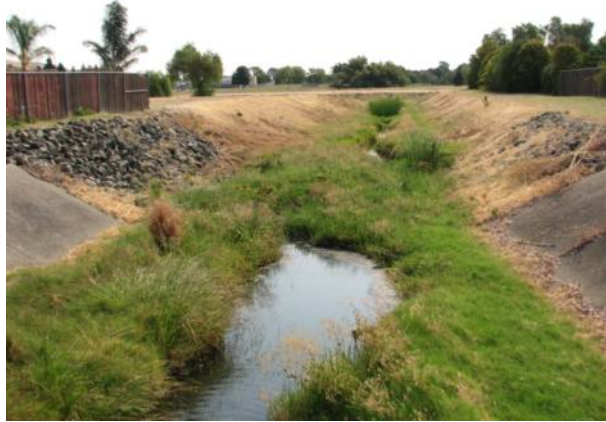
Looking downstream towards Laurel Creek at
Gulf Drive (Summer 2013)
